USATECOM PROJECT NO. 4-4-0180-01

FINAL REPORT OF ENGINEERING FLIGHT TEST 0F THE CH-37 B

MARCH 1965

U.S. ARMY AVIATION TEST ACTIVITY

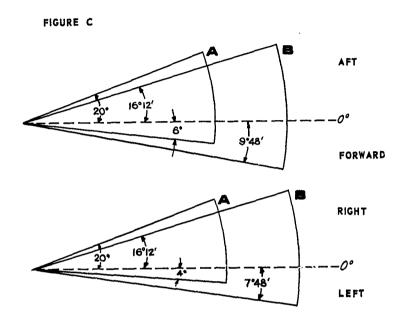
A~BLADE PITCH VARIATION OF THE CH-37A B~BLADE PITCH VARIATION OF THE CH-37A

Static longitudinal speed stability was determined to be positive for all airspeeds above 45 knots at all flight conditions. There were no objectionable discontinuities and the speed stability became more positive as airspeed was increased. Qualitative pilot comments indicated that the static speed stability characteristics were the same with the ASE both "on" and "off." A comparison of the CH-37B longitudinal control positions as a function of calibrated airspeed is presented in Figure C.

The CH-37B required an average of 7 percent more forward longitudinal cyclic control and the speed stability gradient became more positive as the airspeed was increased. The forward control position and more positive stability were attributed to the greater nose-up moment created by the new stabilizer location. Qualitatively, there was no detectable difference between the static longitudinal speed stability characteristics of the CH-37A and the CH-37B.

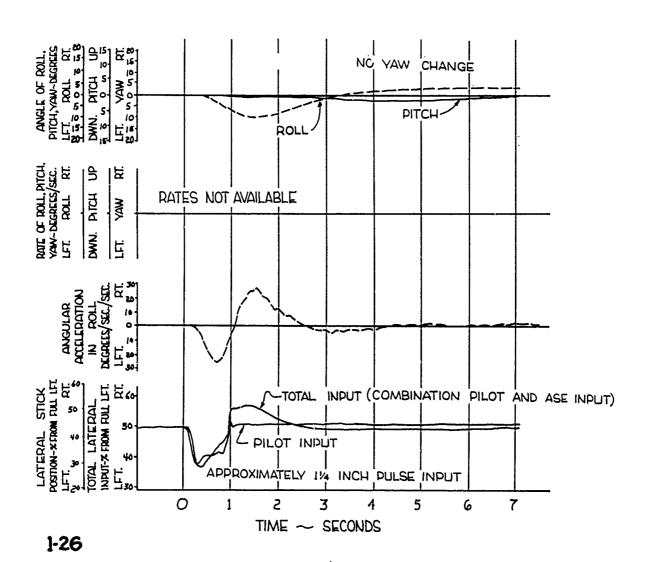
## FIGURE NO.25 RESPONSE TO A LEFT LATERAL PULSE~ASE ON CH-37B, U.S.A., S/N 54-0998

FULL LATERAL TRAVEL = 15 INCHES C.G. LOCATION = STATION 236.5 (MID) AVG. GROSS WEIGHT = 30,500 LB. HOVER (IGE)

TRIM CAS = 0 KNOTS
DENSITY ALTITUDE = 2100 FT.
RPM = 2730/195
PITCH ------ROLL ------YAW -------

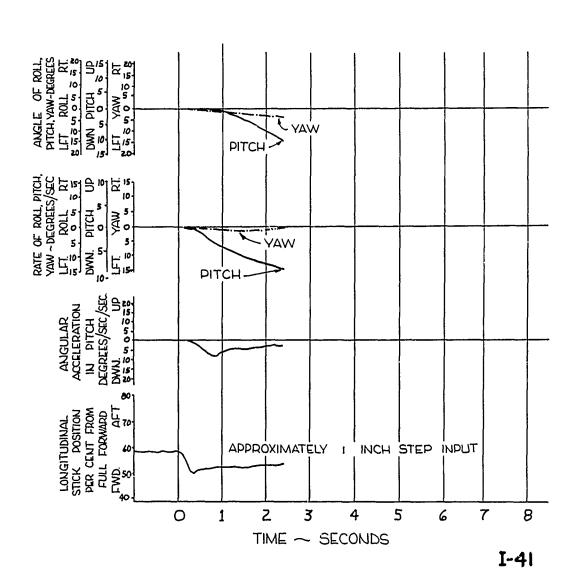
#### FIGURE NO.40 RESPONSE TO A FWD LONGITUDINAL STEP —ASE OFF CH-37B, U.S.A., S/N 54-0998

FULL LONGITUDINAL TRAVEL = 16 INCHES C.G. LOCATION = STATION 236.5 (MID) AVG. GROSS WEIGHT = 30,900 LB.

TRIM CAS = 0 KNOTS DENSITY ALTITUDE= 950 FT. RPM = 2720/194

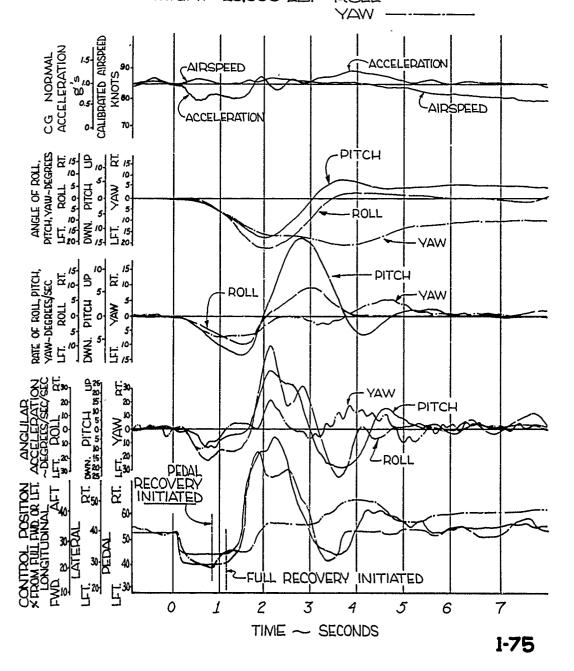
## FIGURE NO.73 RESPONSE TO A THREE-AXIS HARD-OVER INDUCED BY ACTUATION OF TEST SWITCH

CH-37B, LI.S.A., S/N 54-0998 FULL LONGITUDINAL TRAVEL = 16 IN. FULL LATERAL TRAVEL = 15 IN. FULL PEDAL TRAVEL = 3.8 IN. C.G. LOCATION = STATION 239 AVG. GROSS WEIGHT = 25,300 LB.

TRIM CAS=85 KNOTS DENSITY ALTITUDE=8300 FT. RPM=2605/186 PITCH -ROLL

2.2.6.4.2 ASE Feedback Circuit Failures (Oscillating Hard-overs) (Reference Figures No. 68 through 73, Section 3, Appendix I)
